XM587E2/XM724 Electronic Time Fuses

Developmental Test/Operational Test (DT/OT) II

by W. L. Aschenbeck

November 1979

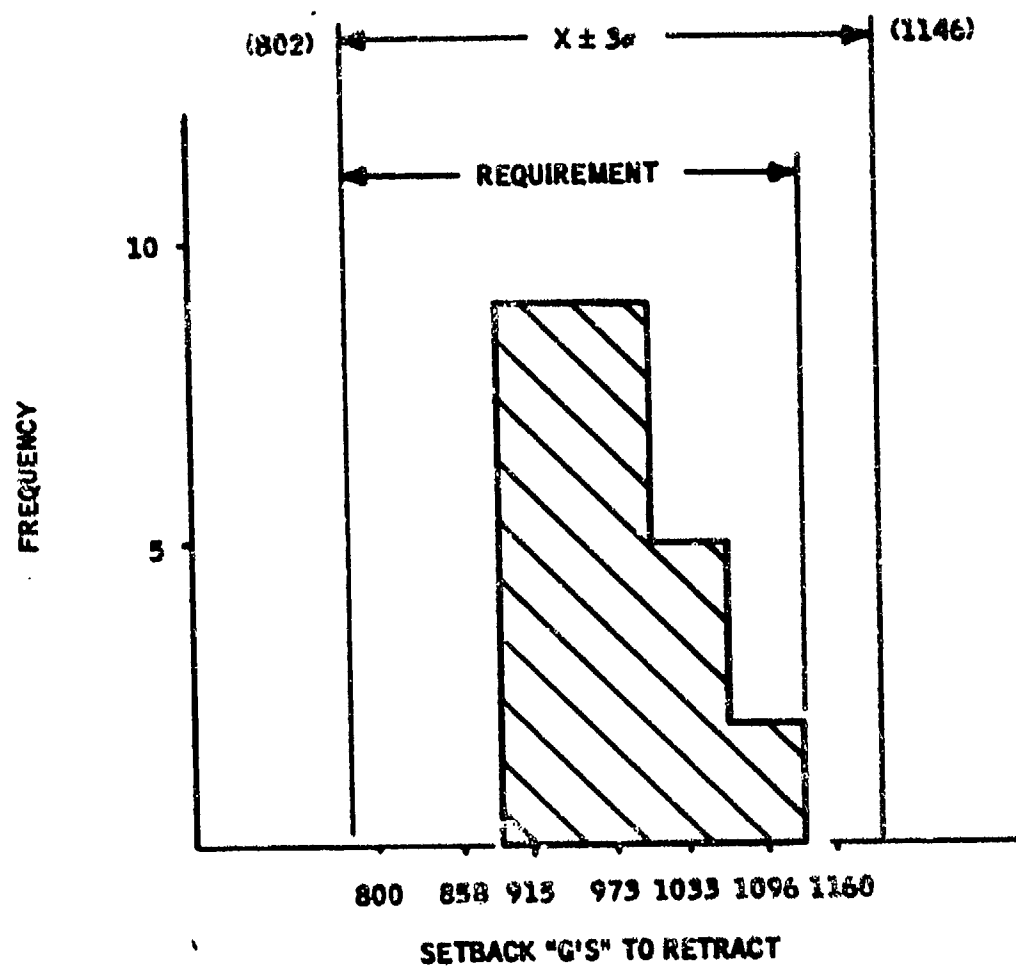
Figure 13. Setback pin operational test results.

A minor problem was experienced during the fabrication and testing of the second lot of S&A modules. The problem involved the specified setback pin operation test, M-106 (Reference Drawing 11720300). Five units from the 125 unit sample failed when the setback pin did not retract and lock-out at the specified 1,100 G's. Each unit from that lot was then subjected to this test to eliminate all of the defects. Eight additional defects were found as a result of this 100 percent screening operation.

- A) Three units from the first five failures were disassembled and examined. No apparent reason for failures was found.
- B) The 10 remaining failures were tested to determine the G level required to retract and lock-out the setback pin. The results of this test were as follows:
  - 7 units functioned at 1,160 G's
  - 2 units functioned at 1,430 G's
  - 1 unit did not function at 1,800 G's.

- 1 unit - no obvious failure mode
- 1 unit - damaged setback spring
- 1 unit - damaged setback pin

The above data was reviewed with HDL. Two corrections for this problem were recommended: A) revise the bias level of the setback spring and B) revise the upper limit of the requirements.

ECP-724-MHR-033, recommended changing the upper limit of the requirement from 1,100 G's to 1,200 G's.

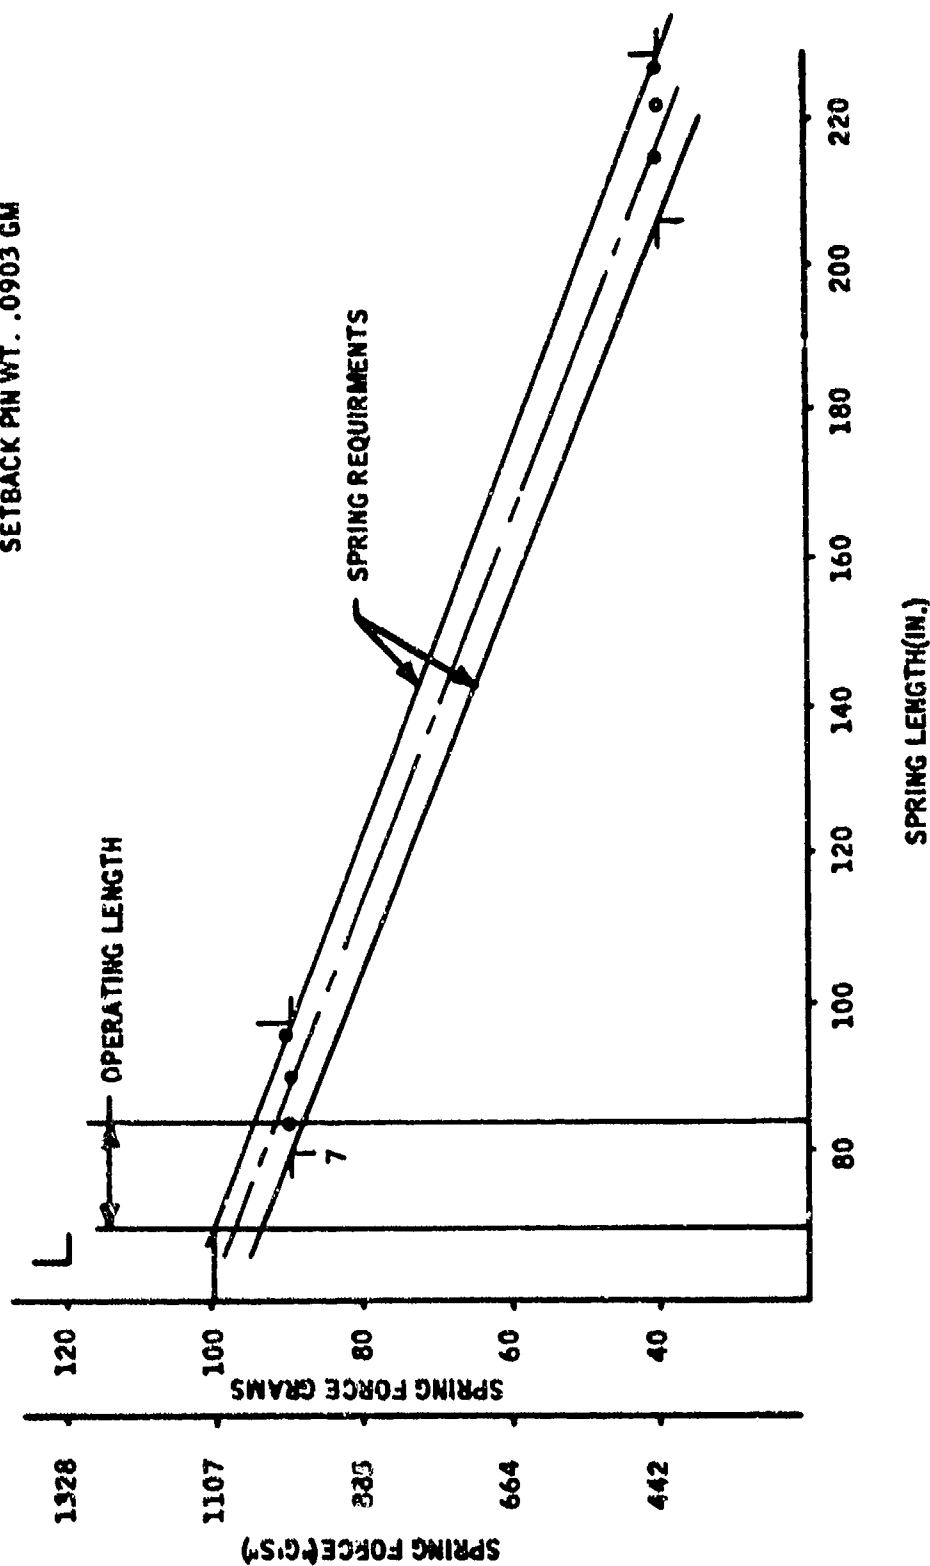
Figure 14. Setback pin operational analysis.

The units which did not function at 1,160 G's were disassembled and analyzed to determine the cause of failure with the following results:

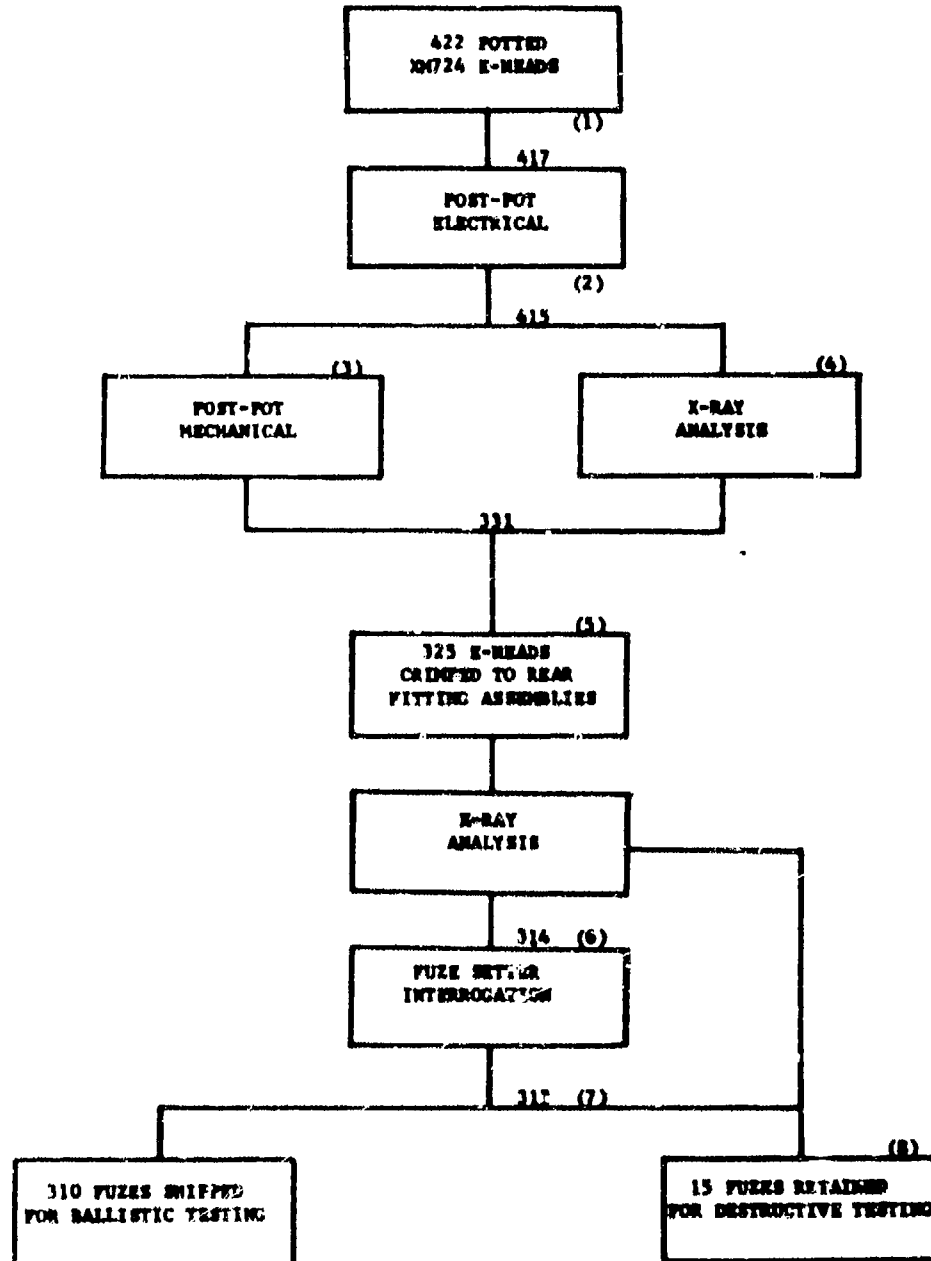
A total of 422 XM724 E-heads were encapsulated. The following flow diagram depicts the yield at each inspection/test operation.

- (1) Five E-heads lost during potting process, four of which exhibited damaged O-rings and one of which was over potted.
- (2) Two E-heads were rejected by the automatic fuse test station.

- (3) A total of 32 E-heads were rejected for various mechanical reasons:
  - a) Five E-heads had nose plugs below .012 or .018 above ogive.
  - b) One E-head traveler was missing.

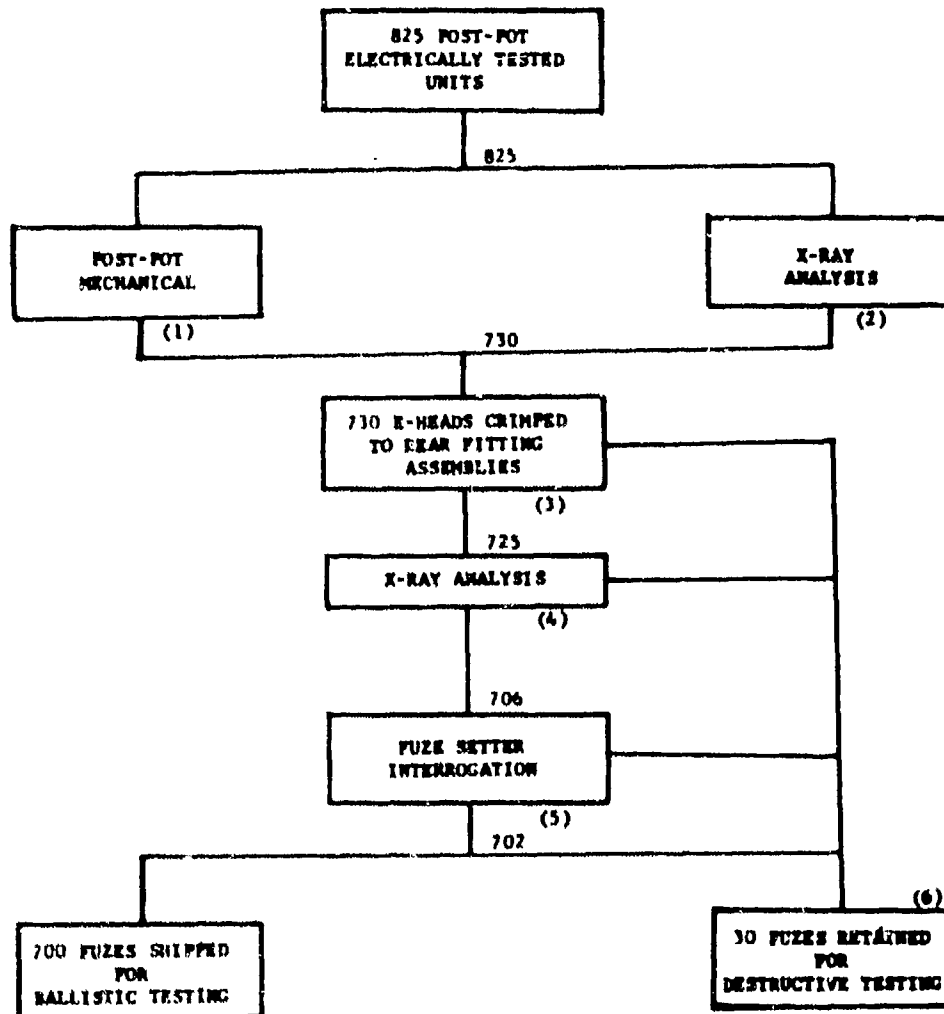
A total of 825 M05B7K2 E-heads passed electrical post-pot testing. The following flow diagram depicts the yield at each inspection/test station:

- (1) TOTAL OF SEVEN (7) E-HEADS WERE REJECTED DURING THE MECHANICAL POST-POT INSPECTION. ALL SEVEN (7) E-HEADS COULD NOT BE MATCHED WITH THEIR UNIQUE TRAVELER.

- (2) A TOTAL OF 88 E-HEADS WERE SORTED FROM THE LOT FOR EXHIBITING CRACKED TRANSFORMER CORES.
- (3) FIVE (5) FUZZES WERE REJECTED AFTER BEING CRIMPED BECAUSE OF THE FOLLOWING REASONS:

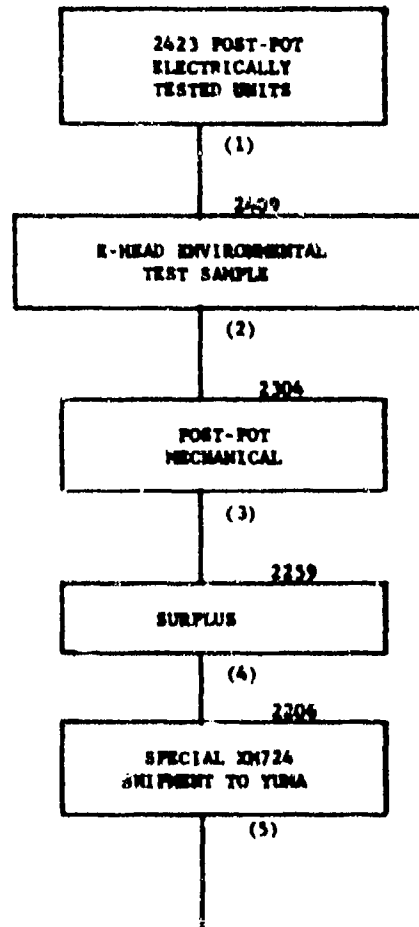
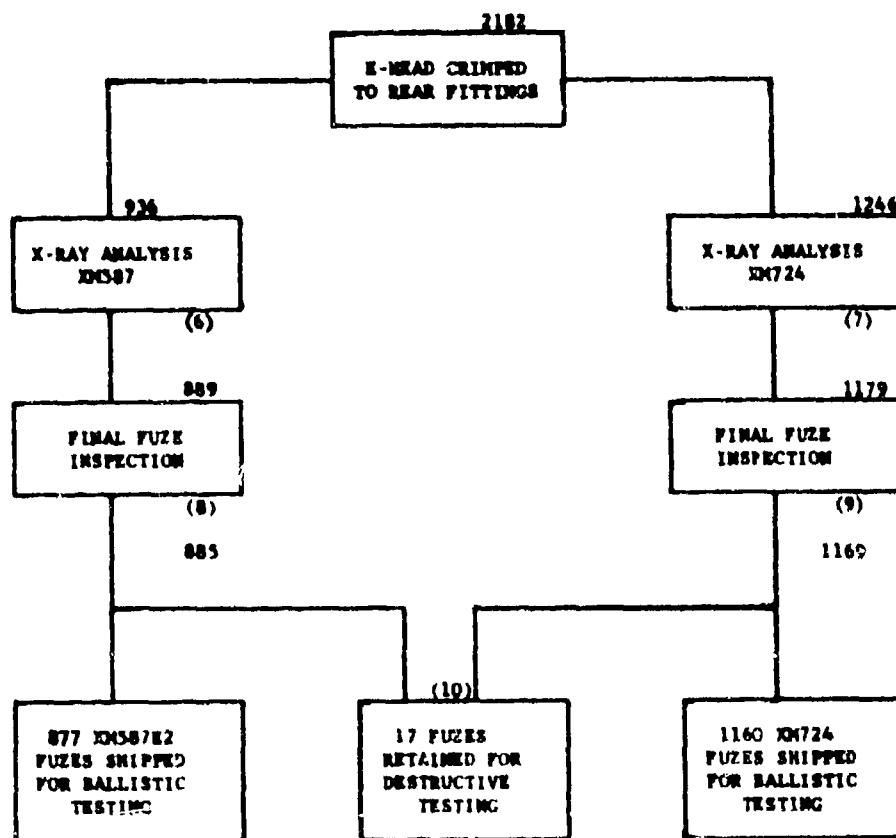
A total of 2423 XM587E2 E-Heads were subjected to Electrical Post-Pot Testing. The following flow diagram depicts the yield at each inspection/test station.

- (1) A total of 14 E-Heads were rejected electrically because of the following:
  - a) 1 showed contaminant on setting ring.
  - b) 1 was marginally below spec. tolerance (Time for scalar going low to time of d-t. fn.).
  - c) 12 exhibited either oscillator, interface, or scalar problems.
- (2) 105 units were randomly selected to be subjected to operating tests per para. 4.4.6 of spec. 11711430.
